## **FIRES IN SWEDISH MATCH FACTORIES IN THE 1920's CAUSED BY WHITE PHOSPHORUS-CONTAMINATED RED PHOSPHORUS**

Rediscovered documents reveal problems in the Swedish match industry due to contaminated red phosphorus in the 1920s.

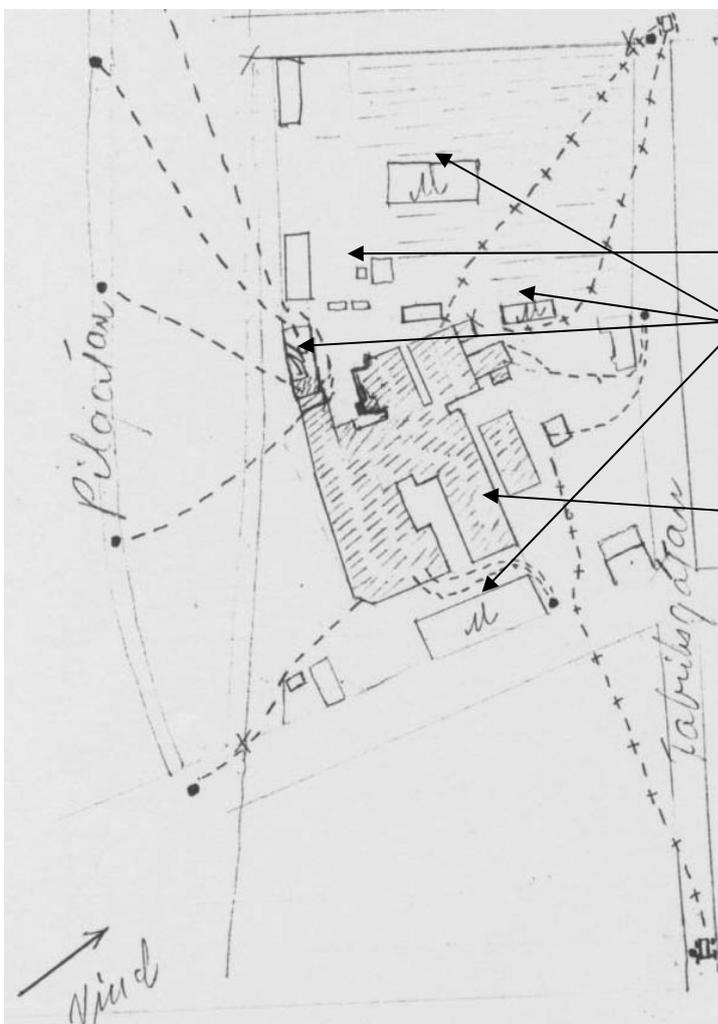
*The Fire brigade's sketch over the fire at WTF in 1922. (VKA BS DI)*

The Police and fire protocol verifies fire in a polishing drum at the drying box on the west side of the splint hall. In the newspaper it was said that fire had been seen in a slot of one of the drying boxes, in, or close to, one of the drying boxes in the splint hall. Fire had also been seen from outside coming out of an airshaft over the splint hall roof.

As the fire alarm was registered at 9:25 PM, the Växjö fire brigade and reserve corps turned out with the tool wagon, after that with the mechanical ladder, and finally with the small and the larger fire steam engines. At 9:28 PM, six firemen with a foreman were in place. Fire Master Zsar expressed his opinion that the fire already was impossible to extinguish or to subdue. The big lathe-hall was on fire.

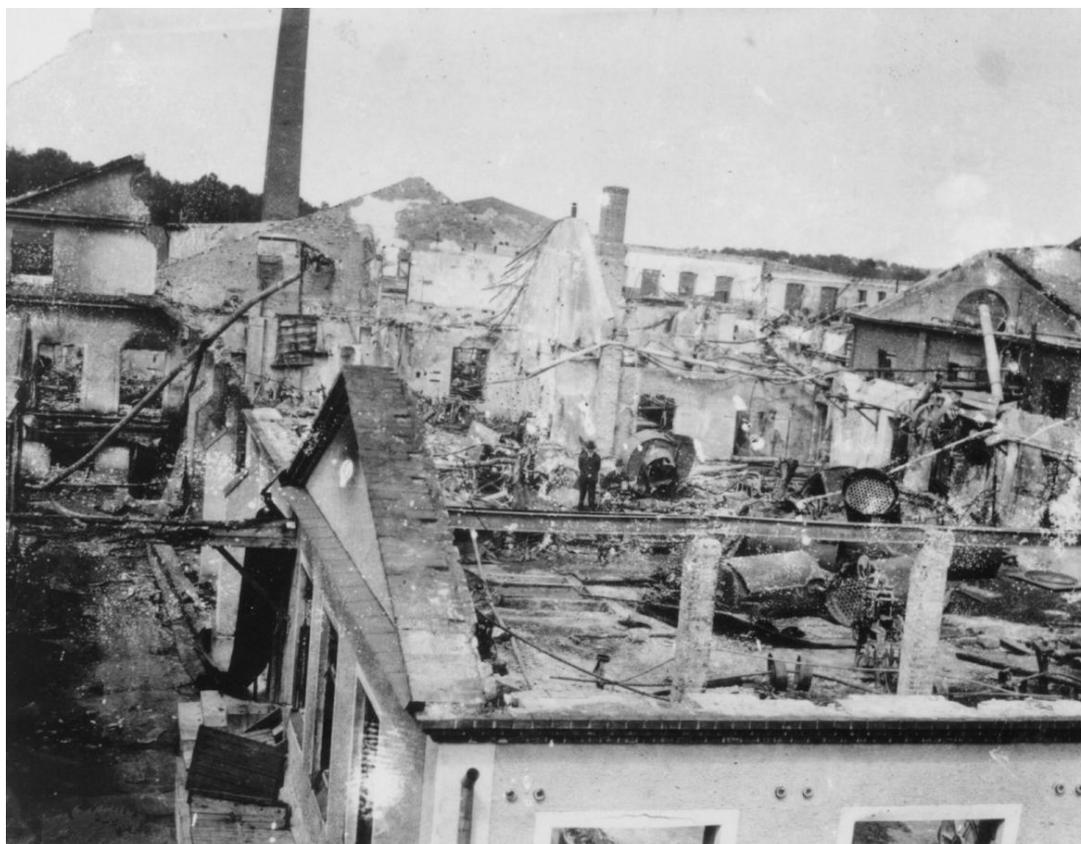
*WTF  
splint  
hall  
June 1  
1922  
(photo SM  
WTF).*

At 1:00 AM on May 31, the fire was under control, and at 7:00 PM the fire brigade's extinguishing of the fire was finished. The public prosecutor held during the day a police interrogation about the fire. Earlier cases of chemical self-ignition were known and was considered the reason of the fire. The main personnel at WTF and of the fire brigade were asked about observations during the fire and their opinion about the possible reason of the fire. Some evidence pointed at heating of a bearing in the roller, but it could not be proved.

No chemicals that could have caused the fire were to be found. The investigation was closed without finding out the reason for the fire. (VLA FSTF F:6)

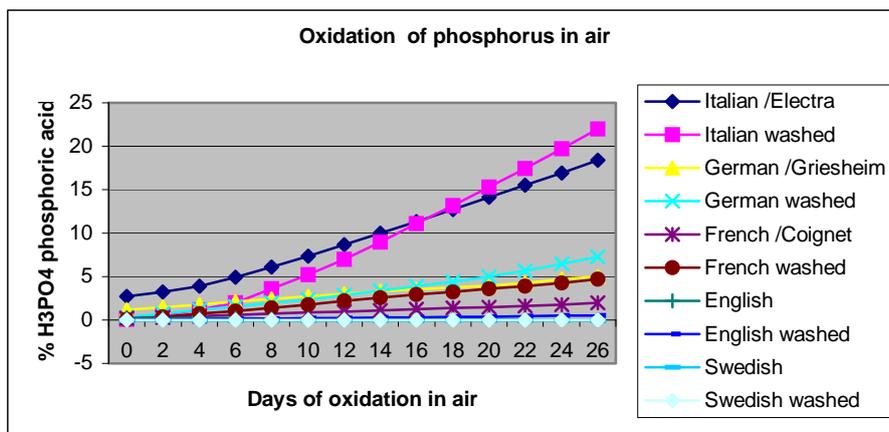
The diagram shows the acidity of various phosphorus brands as a function of air exposure time. In practice their disposition to get acid in relationship with air. The test result is expressed in curves as a specification of the investigated sample. From the curves we conclude that the washed phosphorus oxidise considerably faster than the unwashed.

The investigation show that the Swedish phosphorus had the lowest primary acidity, *i.e.*, the lowest degree oxidation. While the Italian washed, exhibited the highest degree of oxidation.

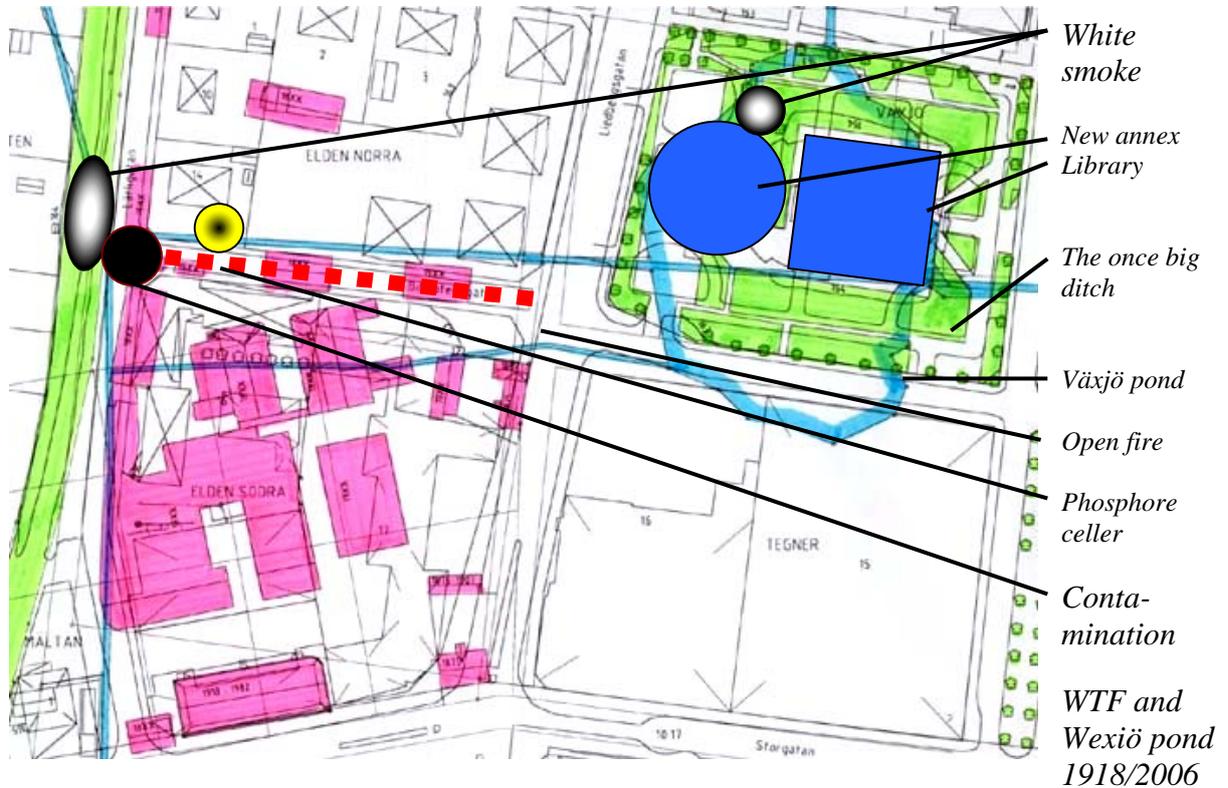
Recently I found an excavator digging a 3 m deep pit in Lärkgatan, where the Wexjö Match Factory (WTF) once was located. As digging, a white cloud came up from the ground enclosing the excavator, smelling strongly. Going down into the pit, the workers found the ground full of white-gray nearly burning ground material.

The workers led me to find a person that 1983 worked with excavation of the roads in the same area. Several phosphorus fires had then started when it was digged in Biblioteksgatan. The crossing of Biblioteksgatan and Lärkgatan is a waste disposal site.
